Service Bulletin 011-7210

Relief valves prevent damage to wrist motor slip ring housing

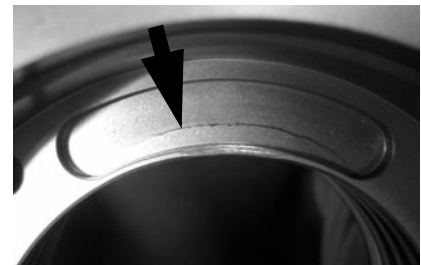
Over pressurization of the Jaw Close 5B circuit/tilt circuit inside the wrist motor may cause the slip ring housing to fracture and allow hydraulic fluid to flow directly into the wrist case drain (hydraulic return). Properly installed over-pressure relief valves will prevent this from occurring.

Without relief valves, housing fractures may occur when the pressure in the cylinder exceeds 5000 psi. This typically occurs when the jaw or tilt assembly is involved in a collision and the piston is forced open. An typical fracture is shown at right (arrow).

To prevent an over-pressure event, a relief valve must be installed on each hydraulic circuit including the jaw/tilt function (see sample RigMaster and Pan & Tilt schematics on following page). Verify that all rate slave arms and pan & tilt units have properly positioned and adjusted over-pressure relief valves installed for all functions.
